Flood Control Project Maintenance
2012 Structure Summary Report
Overall Unit and Item Ratings

Lake County Watershed Protection District

Clover Creek Diversion Structure

Levee Inspection Report By Mile - Structure 2012

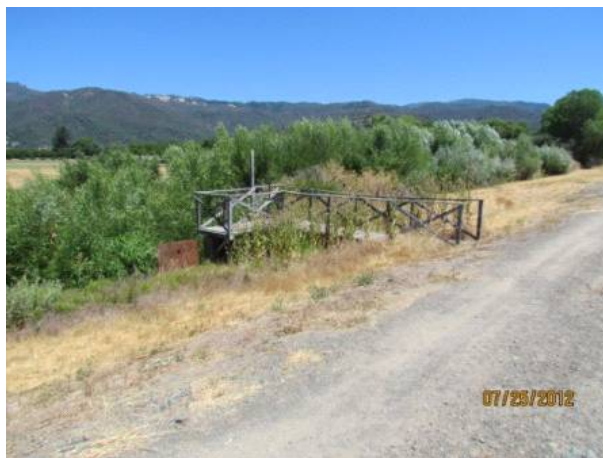
Levee Mile Report Line	1
Start Levee Mile	0.00
End Levee Mile	0.00
Location	
Category	Structures
Item	Photo Documentation

LMR No.	Levee Mile		Category	Item	Location *	Rating **	Action/Comment	GPS Latitude/Longitude		Issue No. Photo
	Start	End						Start	End	
1	0.00	0.00	Structures	Photo Documentation		N	Inspector Comments: Clover Creek Diversion Structure has three culverts with two flap and slide gates to divert the water during high water season.	39.177050 ° -122.898750 °	39.177050 ° -122.898750 °	1 Y
2	0.00	0.00	Structures	Vegetation & Obstructions		M	Inspector Comments: The channel had vegetation and scattered obstructions.	39.177050 ° -122.898750 °	39.177050 ° -122.898750 °	2 Y
3	0.00	0.00	Structures	Shoaling / Sedimentation		M	Inspector Comments: Minimal amount of shoaling and sedimentation were present on the channel.	39.177050 ° -122.898750 °	39.177050 ° -122.898750 °	3 Y
4	0.00	0.00	Structures	Erosion / Bank Caving		A	Inspector Comments: There was no visible active erosion or bank caving observed.	39.177050 ° -122.898750 °	39.177050 ° -122.898750 °	4

View of the diversion structure.

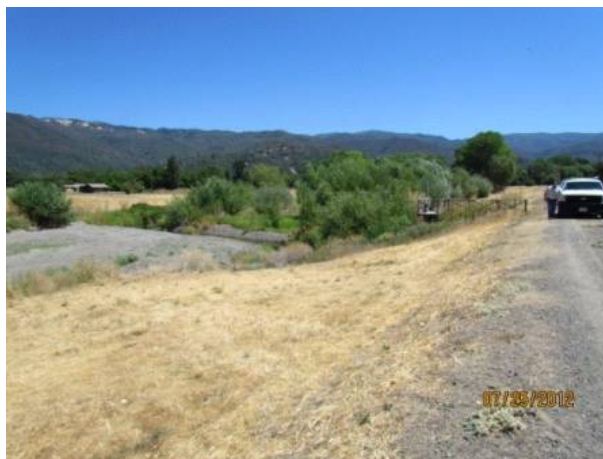
Levee Mile Report Line	2
Start Levee Mile	0.00
End Levee Mile	0.00
Location	
Category	Structures
Item	Vegetation & Obstructions

View of the vegetation at the diversion structure.

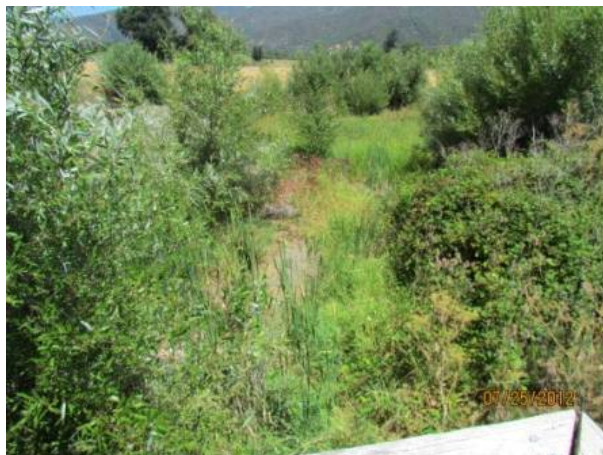
Levee Mile Report Line	2
Start Levee Mile	0.00
End Levee Mile	0.00
Location	
Category	Structures
Item	Vegetation & Obstructions

View of the vegetation at the structure inlet.

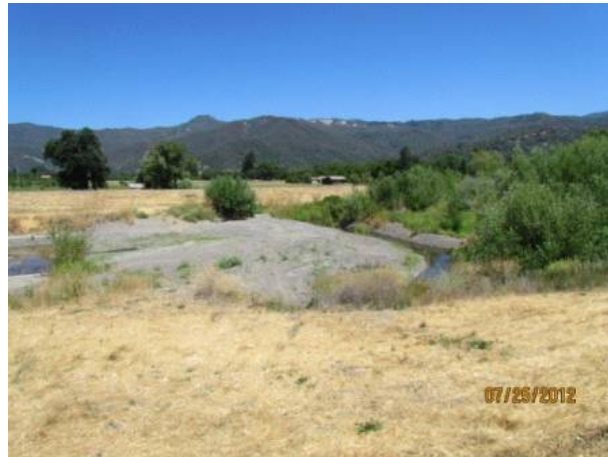
Levee Mile Report Line	3
Start Levee Mile	0.00
End Levee Mile	0.00
Location	
Category	Structures
Item	Shoaling / Sedimentation

View of the channel.

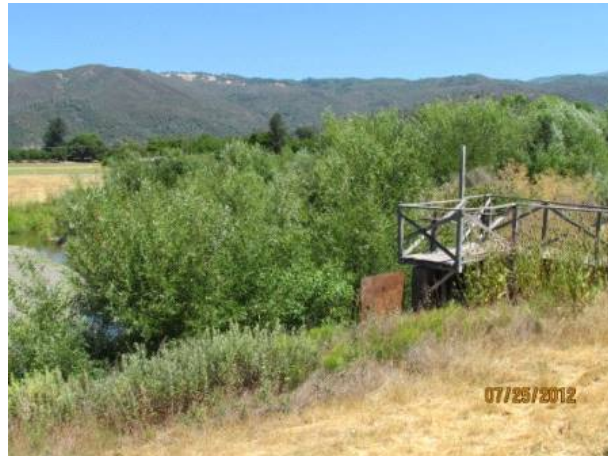
Levee Mile Report Line	7
Start Levee Mile	0.00
End Levee Mile	0.00
Location	
Category	Structures
Item	Culverts: Inlets / Outlets

View of the culvert inlet.

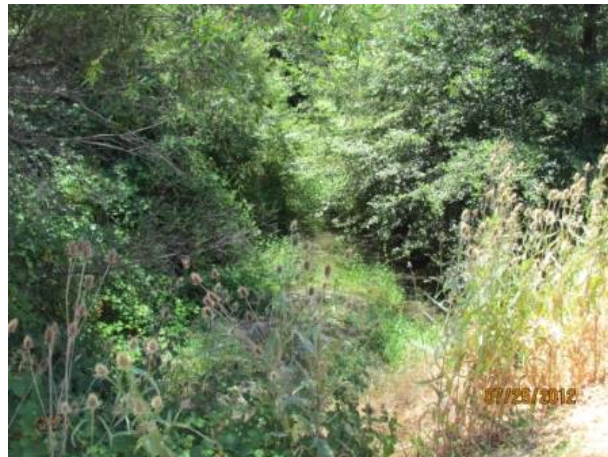
Levee Mile Report Line	7
Start Levee Mile	0.00
End Levee Mile	0.00
Location	
Category	Structures
Item	Culverts: Inlets / Outlets

View of the culvert outlet.

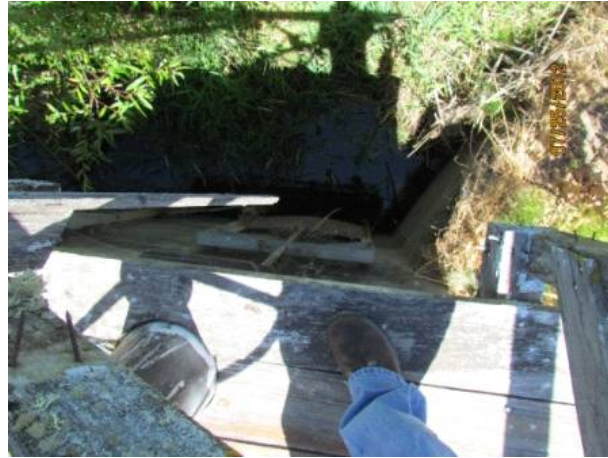
Levee Mile Report Line	12
Start Levee Mile	0.00
End Levee Mile	0.00
Location	
Category	Structures
Item	Sluice/Slide Gates

11	0.00	0.00	Structures	Flap Gates		A	Inspector Comments: Flap gates appeared to be in good condition.	39.177050 ° -122.898750 °	39.177050 ° -122.898750 °	11
12	0.00	0.00	Structures	Sluice/Slide Gates		A	Inspector Comments: The slide gates appeared to be in good working condition.	39.177050 ° -122.898750 °	39.177050 ° -122.898750 °	12 Y
13	0.00	0.00	Structures	Electric Gate Operators		N	Inspector Comments: This item does not apply to this inspection.	39.177050 ° -122.898750 °	39.177050 ° -122.898750 °	13
14	0.00	0.00	Structures	Manual Gate Operators		A	Inspector Comments: The manual gate operator appeared to be operational.	39.177050 ° -122.898750 °	39.177050 ° -122.898750 °	14 Y

View of the slide gate.

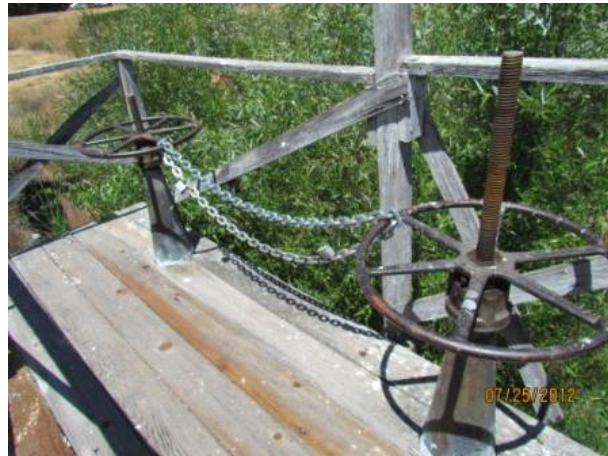
Levee Mile Report Line	14
Start Levee Mile	0.00
End Levee Mile	0.00
Location	
Category	Structures
Item	Manual Gate Operators

View of the manual gate operator.

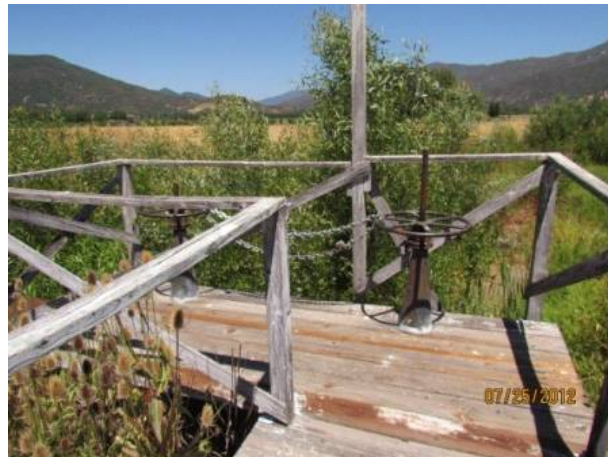
Levee Mile Report Line	23
Start Levee Mile	0.00
End Levee Mile	0.00
Location	
Category	Structures
Item	Safety

20	0.00	0.00	Structures	Trash Rakes		N	Inspector Comments: This item does not apply to this inspection.	39.177050 ° -122.898750 °	39.177050 ° -122.898750 °	20
21	0.00	0.00	Structures	Other Metallic Items		N	Inspector Comments: This item does not apply to this inspection.	39.177050 ° -122.898750 °	39.177050 ° -122.898750 °	21
22	0.00	0.00	Structures	Monolith Joints		N	Inspector Comments: This item does not apply to this inspection.	39.177050 ° -122.898750 °	39.177050 ° -122.898750 °	22
23	0.00	0.00	Structures	Safety		M	Inspector Comments: The wood railing around the structure was not sturdy but appeared to provide fall protection.	39.177050 ° -122.898750 °	39.177050 ° -122.898750 °	23 Y

View of the guard rail.

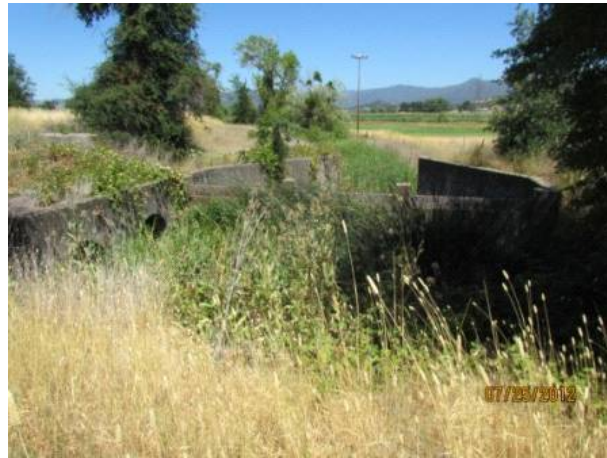
Levee Mile Report Line	1
Start Levee Mile	0.00
End Levee Mile	0.00
Location	
Category	Structures
Item	Photo Documentation

LMR No.	Levee Mile		Category	Item	Location *	Rating **	Action/Comment	GPS Latitude/Longitude		Issue No.
	Start	End						Start	End	
1	0.00	0.00	Structures	Photo Documentation		N	Inspector Comments: Highland Canal Diversion Weir works as a control point that diverts water through a culvert during high water season.	39.126317 ° -122.882733 °	39.126317 ° -122.882733 °	1 Y
2	0.00	0.00	Structures	Vegetation & Obstructions		M	Inspector Comments: There were vegetation growth such as cat tails and bushes in the structure which might impede the flow of the water through the culvert.	39.126317 ° -122.882733 °	39.126317 ° -122.882733 °	2 Y
3	0.00	0.00	Structures	Shoaling / Sedimentation		A	Inspector Comments: No Shoaling or sedimentation was present.	39.126317 ° -122.882733 °	39.126317 ° -122.882733 °	3
4	0.00	0.00	Structures	Erosion / Bank Caving		A	Inspector Comments: No active erosion or active bank caving was observed around the structure.	39.126317 ° -122.882733 °	39.126317 ° -122.882733 °	4

View of the weir.

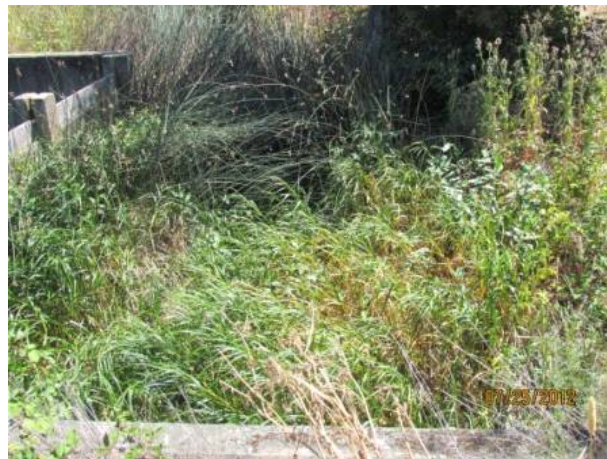
Levee Mile Report Line	2
Start Levee Mile	0.00
End Levee Mile	0.00
Location	
Category	Structures
Item	Vegetation & Obstructions

View of the vegetation growth on the inlet of the structure.

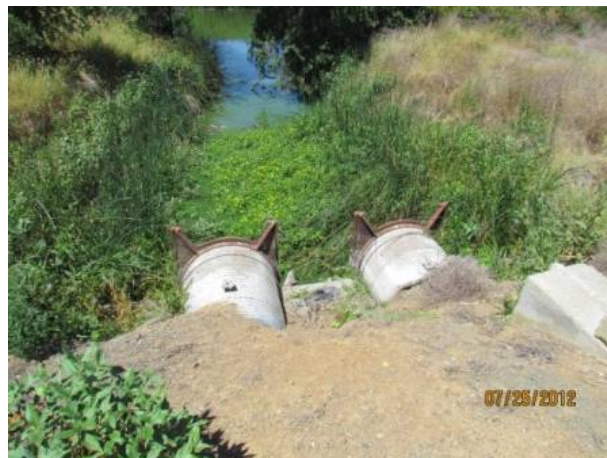
Levee Mile Report Line	2
Start Levee Mile	0.00
End Levee Mile	0.00
Location	
Category	Structures
Item	Vegetation & Obstructions

View of vegetation on the outlet of the structure.

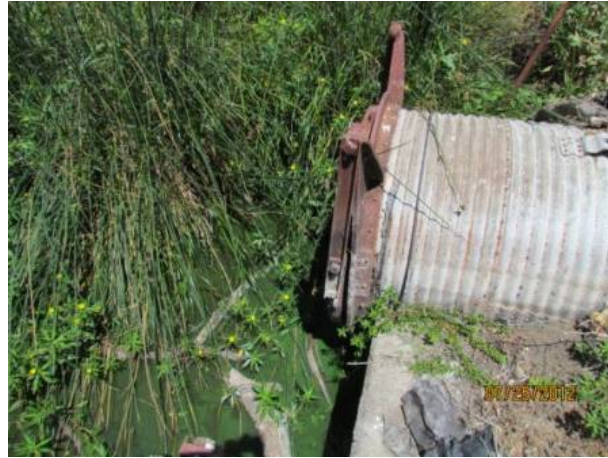
Levee Mile Report Line	6
Start Levee Mile	0.00
End Levee Mile	0.00
Location	
Category	Structures
Item	Encroachments

5	0.00	0.00	Structures	Revetments		N	Inspector Comments: No riprap was present at this structure.	39.126317 ° -122.882733 °	39.126317 ° -122.882733 °	5
6	0.00	0.00	Structures	Encroachments		M	Inspector Comments: Minimal debris was found on outlet of the structure.	39.126317 ° -122.882733 °	39.126317 ° -122.882733 °	6 Y
7	0.00	0.00	Structures	Culverts: Inlets / Outlets		M	Inspector Comments: Vegetation was blocking less than 10% of the culverts opening.	39.126317 ° -122.882733 °	39.126317 ° -122.882733 °	7 Y
8	0.00	0.00	Structures	Culverts: Breaks / Holes / Cracks		A	Inspector Comments: There were no visible breaks, holes or cracks were detected in the culvert.	39.126317 ° -122.882733 °	39.126317 ° -122.882733 °	8
9	0.00	0.00	Structures	Metal Pipes		A		39.126317 ° -122.882733 °	39.126317 ° -122.882733 °	9
10	0.00	0.00	Structures	Trash Racks		N	Inspector Comments: This item does not apply to this inspection.	39.126317 ° -122.882733 °	39.126317 ° -122.882733 °	10

View of the debris at the culvert outlet.

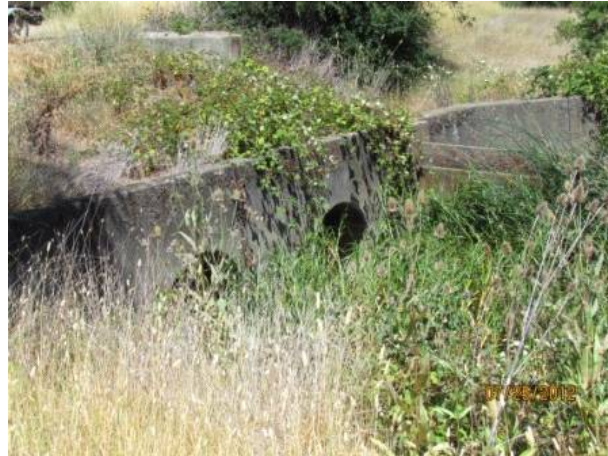
Levee Mile Report Line	7
Start Levee Mile	0.00
End Levee Mile	0.00
Location	
Category	Structures
Item	Culverts: Inlets / Outlets

View of the culvert inlet.

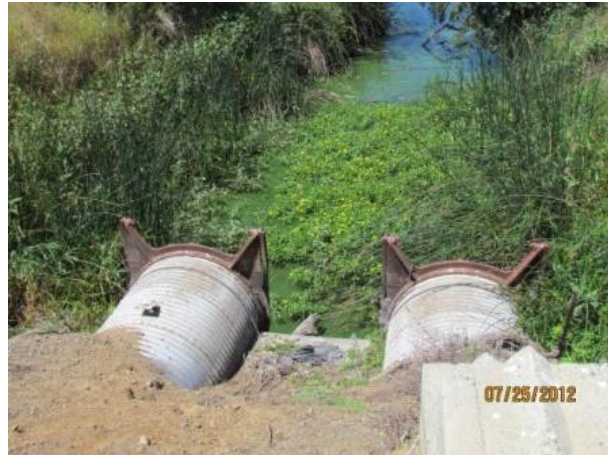
Levee Mile Report Line	11
Start Levee Mile	0.00
End Levee Mile	0.00
Location	
Category	Structures
Item	Flap Gates

11	0.00	0.00	Structures	Flap Gates		A	Inspector Comments: The flap gates appeared to be in working condition.	39.126317 ° -122.882733 °	39.126317 ° -122.882733 °	11 Y
12	0.00	0.00	Structures	Sluice/Slide Gates		N	Inspector Comments: This item does not apply to this inspection.	39.126317 ° -122.882733 °	39.126317 ° -122.882733 °	12
13	0.00	0.00	Structures	Electric Gate Operators		N	Inspector Comments: This item does not apply to this inspection.	39.126317 ° -122.882733 °	39.126317 ° -122.882733 °	13
14	0.00	0.00	Structures	Manual Gate Operators		A	Inspector Comments: Manual gate operator appeared to be in good working condition.	39.126317 ° -122.882733 °	39.126317 ° -122.882733 °	14

View of the flap gate.

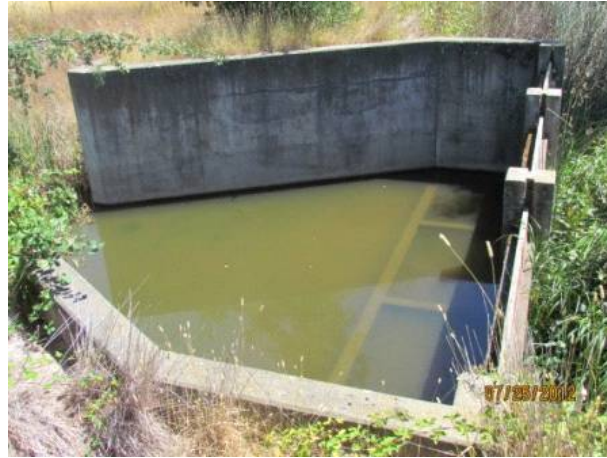
Levee Mile Report Line	15
Start Levee Mile	0.00
End Levee Mile	0.00
Location	
Category	Structures
Item	Concrete Surfaces

LMR No.	Levee Mile		Category	Item	Location *	Rating **	Action/Comment	GPS Latitude/Longitude		Issue No.
	Start	End						Start	End	Photo
15	0.00	0.00	Structures	Concrete Surfaces		A	Inspector Comments: There were minimal cracking and scaling on the concrete structure but it didn't threaten the structural integrity.	39.126317 ° -122.882733 °	39.126317 ° -122.882733 °	15 Y
16	0.00	0.00	Structures	Concrete Tilting / Settlement		A	Inspector Comments: There was no settlement or tilting observed that threaten the structure.	39.126317 ° -122.882733 °	39.126317 ° -122.882733 °	16
17	0.00	0.00	Structures	Concrete Foundations		A	Inspector Comments: No scouring or erosion was found near the structure.	39.126317 ° -122.882733 °	39.126317 ° -122.882733 °	17
18	0.00	0.00	Structures	Security Fencing		N	Inspector Comments: This item does not apply to this inspection.	39.126317 ° -122.882733 °	39.126317 ° -122.882733 °	18

View of the concrete structure.
